Eastern Connecticut Corridor Rail and Transit Feasibility Study (ECRTS)

Preliminary Feasibility Assessment
Appendix D: Thames River Corridor Assessment

March 2023

Prepared by AECOM Technical Services, Inc.

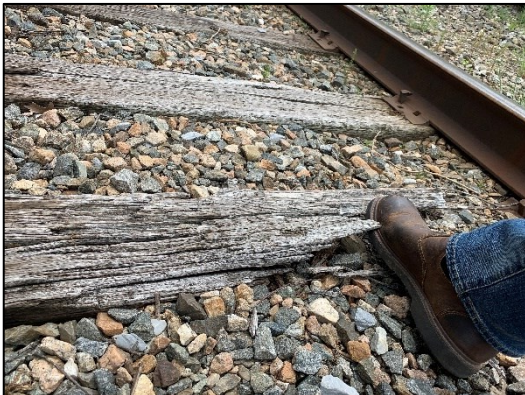
Figure 3: Severe Rotting of Wooden Ties - Lower Bartlett Road (MP 5.05)

Most ties are wooden ties that showed signs of longitudinal cracking and rotting, and it would be recommended they be replaced with concrete ties.

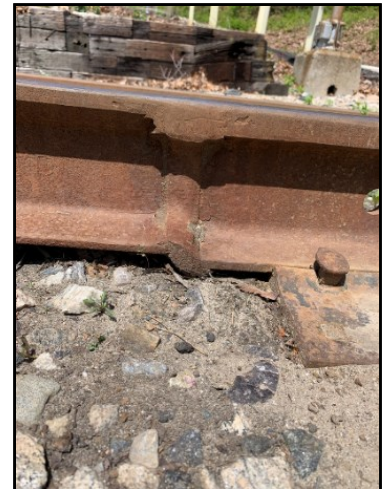
Although the steel rail conditions appeared to be in good shape, the freight railroads currently utilize 100 or 115 RE steel rail which is insufficient for passenger rail service and would need to be upgraded. It appears that Continuous Welded Rail (CWR) was used in many locations.

Figure 2: Weld between 100 and 115 lb. Steel Rail

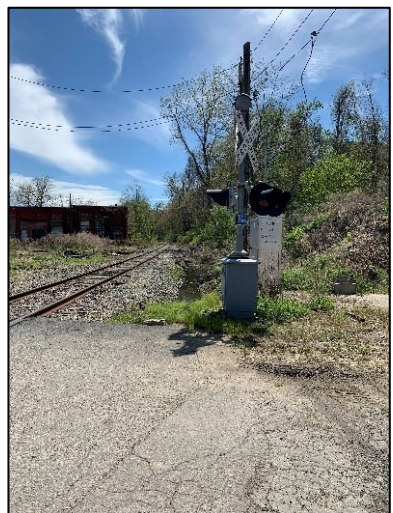
Figure 4: Ponding of Water Alongside Track Bed (MP 11.90)

Ballast / Sub-Ballast was generally in good / fair condition in most observed areas however some spot checks found areas of poor drainage, that would require further investigation of widespread drainage concerns.

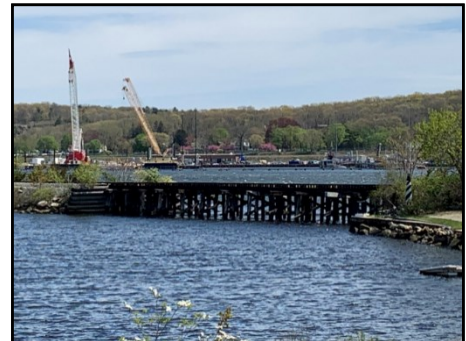
timber trestle, which is not recommended for passenger rail service, given its flammable properties and its tendency to rot from moisture or have potential termite damage.

Figure 5: Timber Trestle Bridge

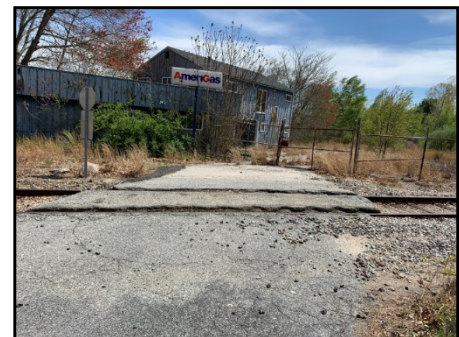
Grade crossings were mostly in poor condition, with numerous crossing surfaces having severe issues. Asphalt crossing surfaces had severe heaving and cracks and should be replaced with either concrete or railway rubber. Other grade crossings either had wood that was severely cracked or unstable earth material as the crossing surface. Many grade crossings were passive crossings that did not have flashers, and most active grade crossings did not have crossing gates. Almost all grade crossings would likely have to be upgraded to include flashers and gate crossings. There were also several grade crossings that appeared to be private and/or unidentifiable that would require further inspection.

Figure 7: Grade Crossing with Severe Heaving (MP 5.05)

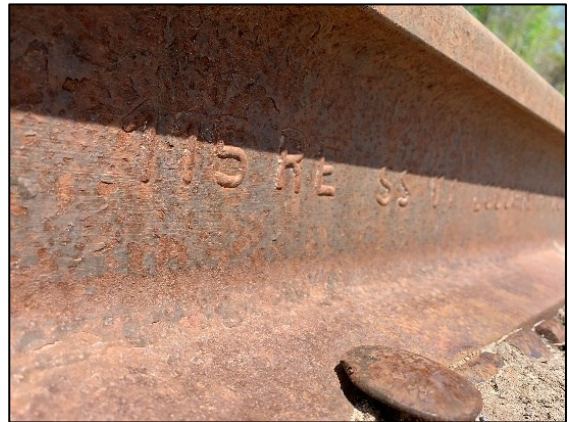
The inspection team performed spot checks of the steel. In areas where the inspection team was able to assess the track, the team observed the steel rails to be in reasonable condition, with weights of 100 or 115RE steel. In the United States, it is recommended that main line steel rail for passenger services uses greater than 130 weight steel, most commonly manufactured 132/133 weight.

Figure 11: 115 RE Steel Rail

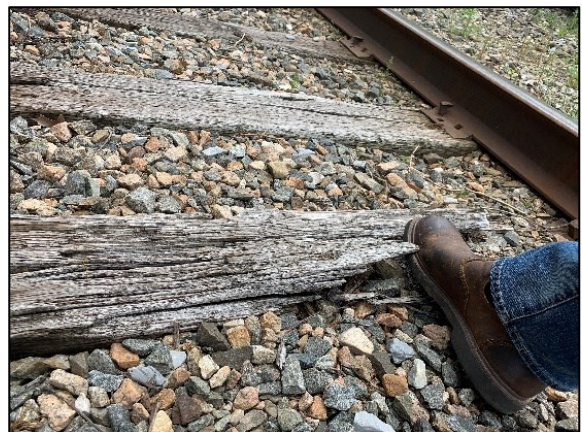
The inspection team performed spot checks of the ties. In areas where the inspection team was able to assess the track, the team observed only the existence of wood ties. Ties were in various conditions, but the team took photos of ties that were in poor condition. Signs of poor ties were either showing longitudinal cracking, severe rotting, or buried, which shows signs of poor drainage.

Figure 12: Wooden Ties with Severe Rotting

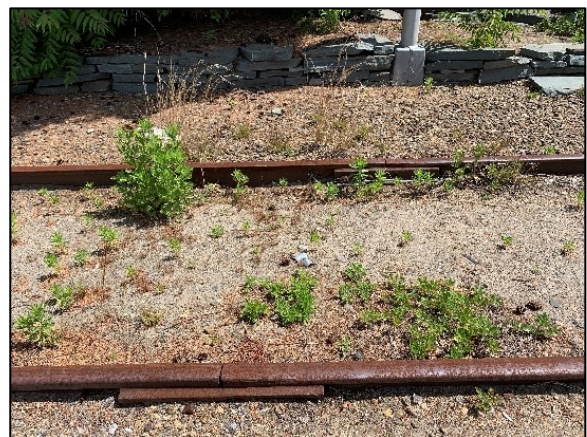
The inspection team performed spot checks of the ballast. In areas where the inspection team was able to assess the track, the team observed the general condition of the ballast to be overall in good/fair condition, but in some spots, it was evident that the ballast condition was poor due to ponding water and excessive vegetation growth. This could signify unstable soil beneath that would require a thicker layer of ballast (>6 inches) or a need to replace the sub-ballast. The inspection team recommends that a follow up in-depth inspection occur along the entire corridor to provide a complete assessment of the ballast profile.

Figure 13: Lack of Visible Ballast/Ties and Vegetation Growth

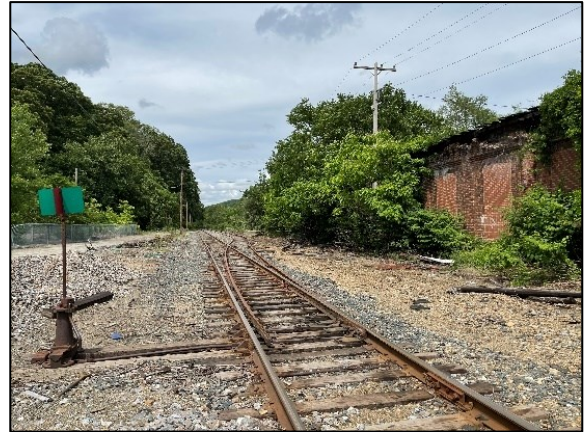
The inspection team was able to identify a few sidings, mainly on the west corridor, with manual switches. These switches were not able to be inspected for functionality and if necessary, it is recommended that further inspection be scheduled to test working condition. Additionally, the prospect of passenger rail service may recommend these sidings have automated switches for safety purposes.

Figure 14: Manual Track Switches and Interlockings

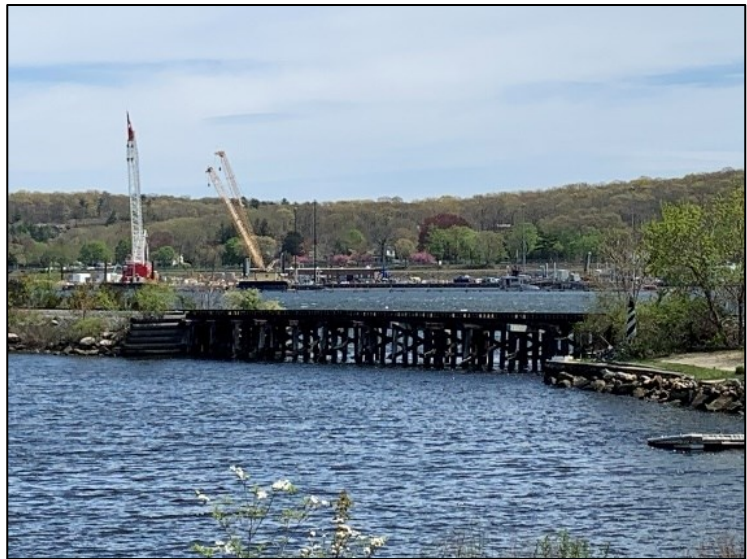
Along the west corridor, seven (7) UG structures were identified as Timber Trestles. Of these seven, only two (2) were able to obtain visual inspection and it was limited for both (MP 3.18 and 11.72). The other five (5) were inaccessible due to the inability to obtain visual inspection safely. Further inspection would require authorized access to these locations to obtain an in-depth review of condition of these bridges.

Figure 22: Timber Trestle (MP 3.18)

Further in-depth inspection and load rating analysis would be required to determine to what extent repairs, rehabilitation, or replacement would be needed for undergrade structures. It is assumed, however, that any timber trestle identified would need to be replaced, as this study team recommends that passenger service does not run on any timber trestle bridges. There were seven (7) timber trestles identified along the west corridor.

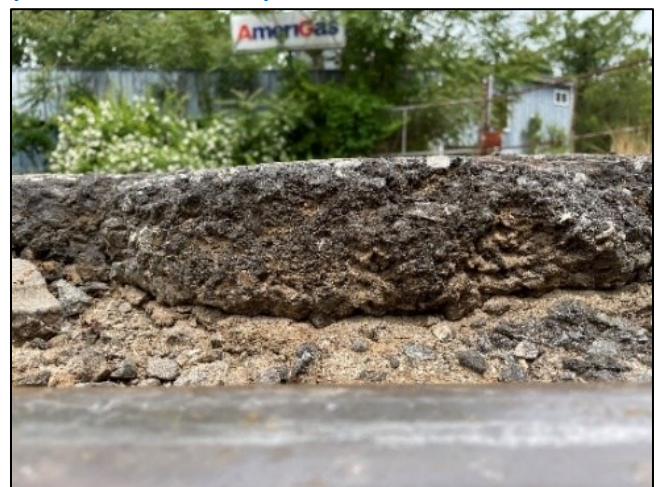
Asphalt crossing surfaces had mixed condition assessments. While some surfaces appeared to show minimal cracking, others were in poor condition and showed signs of heaving, to some degree showing evidence of rubbing against the undercarriage of passing trains.

Figure 30: Elevation of Heaving from Rail Surface (Lower Bartlett Road)

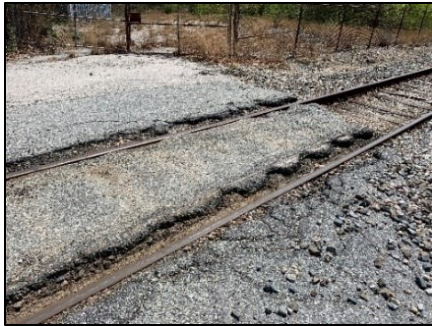
Figure 34: Poor Condition - Lower Bartlett Road (MP 5.05)

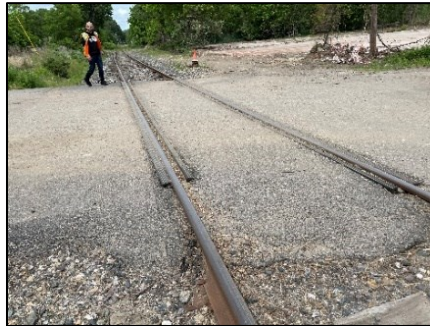
Figure 33: Good Condition - Terminal Way (MP 12.08)

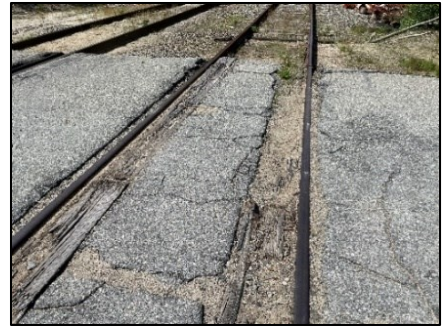
Figure 32: Fair Condition - DOW Chemical (MP 6.08)

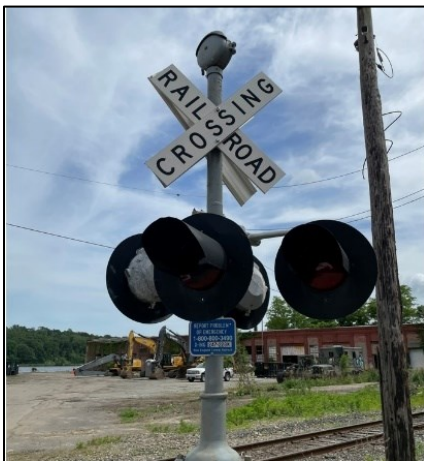
Most active grade crossings observed tended to show flashers only adhered to a crossbuck signpost. In general, it was presumed these were in working condition, but would likely need to be updated to include bells and gates to support passenger rail service.

Figure 40: Terminal Way (MP 11.90)

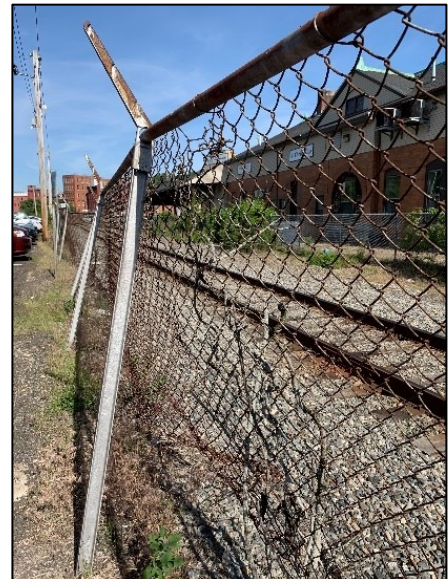
On various observed segments, there were existing chain link fencing that offered ROW protection. In many cases, the fencing was deficient and should be upgraded. A further inspection should identify other segments of the corridor that have either deficient fencing and/or require upgraded fencing for ROW protection.

Figure 45: Damaged Fencing at Old Norwich Train Station (MP 12.3)

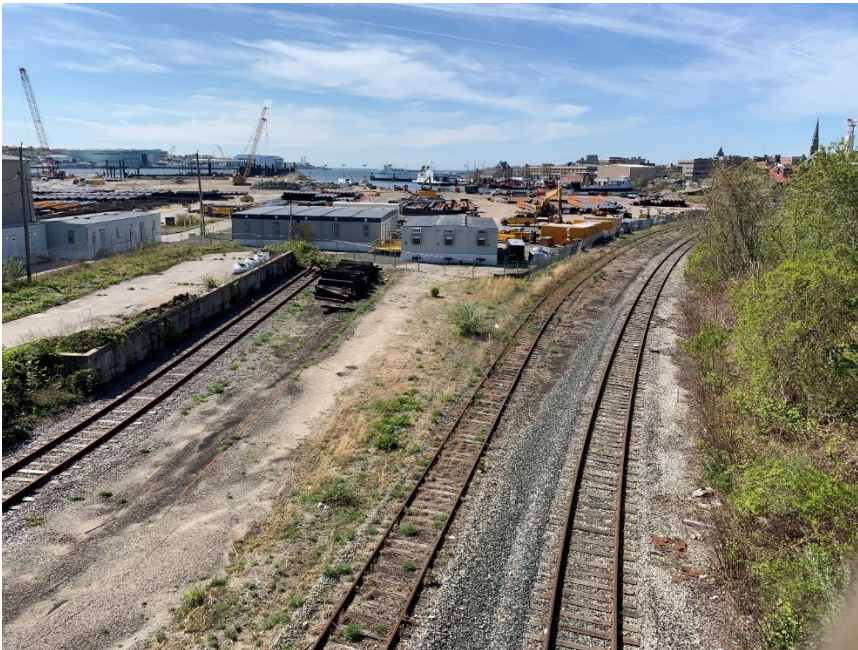
Figure 13: MP 0.62 – OH Bridge - State Pier Road (Looking South)

Two tracks approaching an overhead bridge. It is assumed that only the western track (viewer's right side of the photo) is in active use because the eastern track has a lot of vegetation present. It is a sign of poor drainage, and possibly rotten railroad ties which makes the track unsafe. Walking the right of way with flagmen would be necessary to perform a closer inspection.

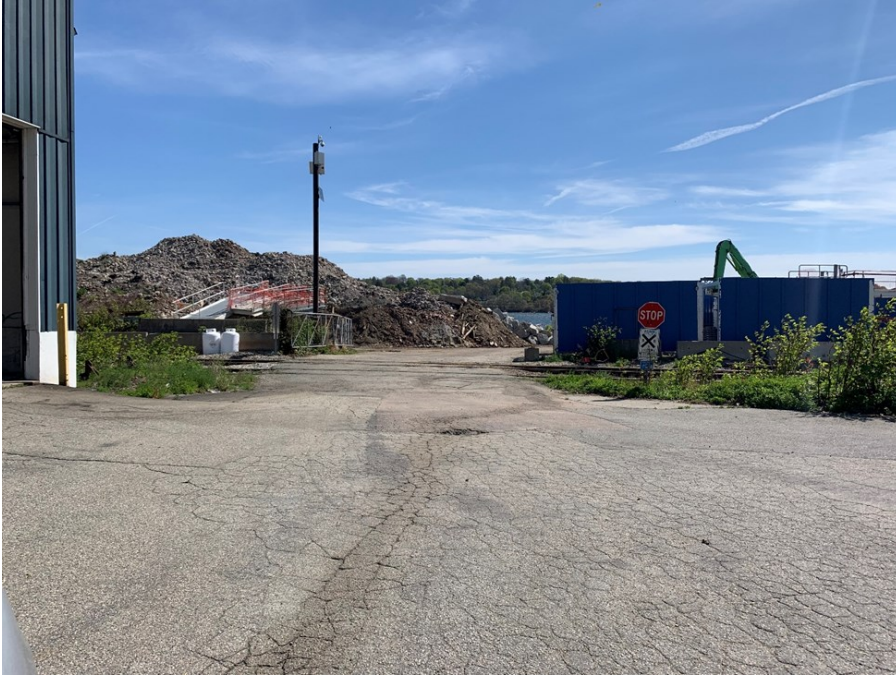
Figure 16: MP 0.91 – Grade Crossing - Approach near Eastern Ave - Looking East

Crossing is in poor condition and is not signaled. Vegetation growing in the gauge – sign of very poor drainage. Most likely, only one track is in active use.

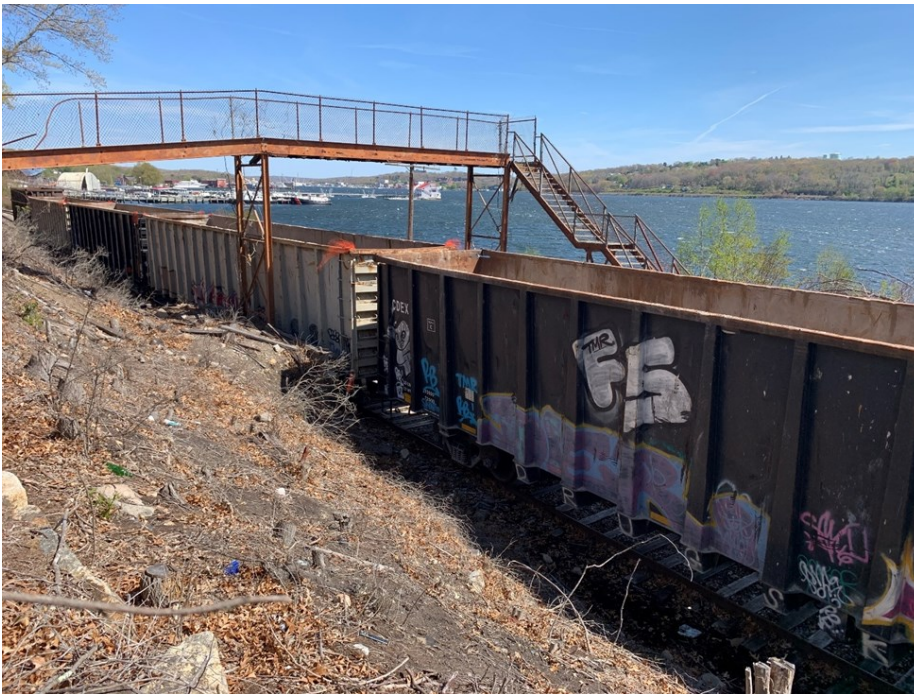
Figure 25: MP 1.07 - OH Bridge – Ped Bridge Riverside Park (Looking Northeast)

The bridge is closed due to its unsafe and unusable condition. Corrosion and missing timber boards. Some steel members have cross-sectional losses. The bridge would have to be removed to make the line safe for passenger service.

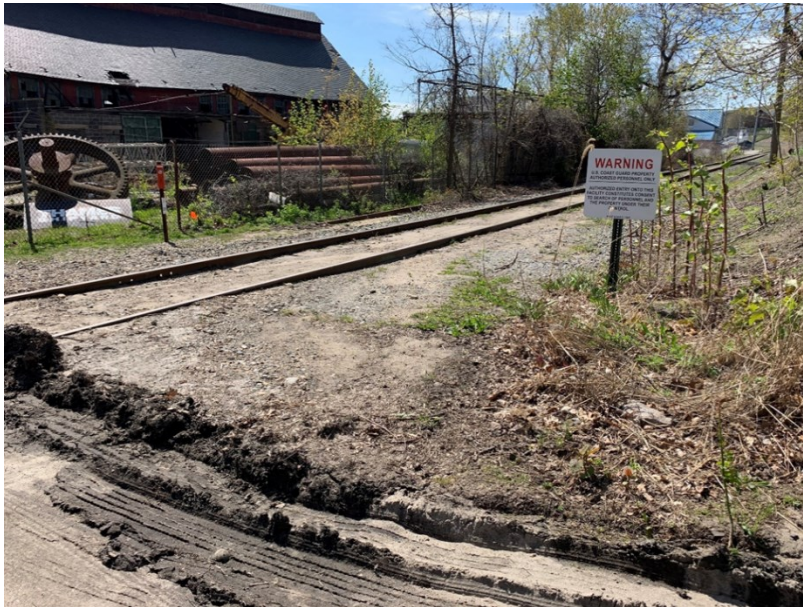
Figure 33: MP 1.79 - Grade Crossing - Farnsworth Street - Old Thames Shipyard (Looking South)

The vehicles crossing the tracks in and out of the shipyard carry a lot of fine material on their tires that gets spread over Farnsworth Street (marks are visible on the asphalt). The material gets washed back towards the tracks after every rainfall. The voids in the ballast get clogged, thus preventing the water from draining away from the tracks. Retaining moisture around the tracks, specifically around the railroad ties causes them to rot and breakdown thus compromising the required structural properties of the track.

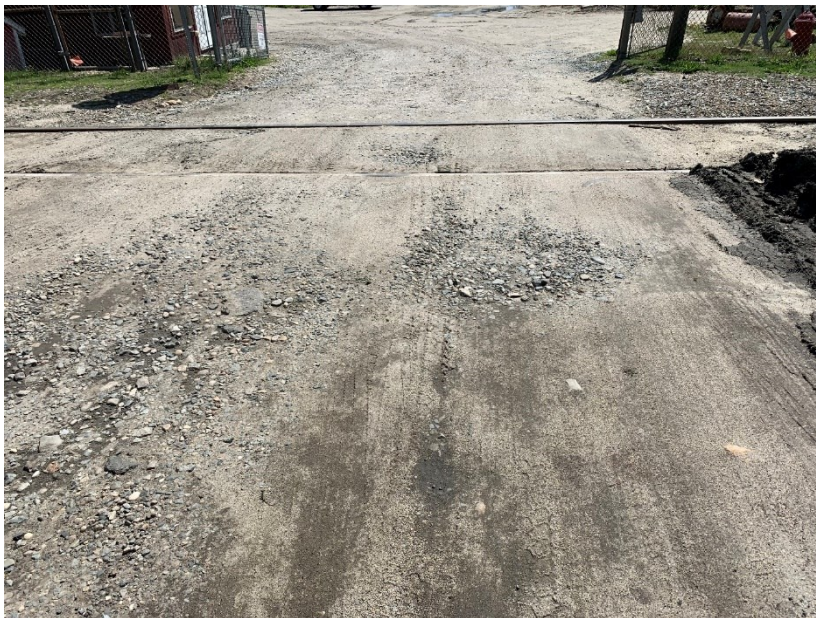
Figure 34: MP 1.79 - Grade Crossing - Farnsworth Street - Old Thames Shipyard (Looking East)

The crossing is covered with a lot of fine material from passing vehicles in and out of the shipyard – will need to be rebuilt with drains to the west of the crossing.

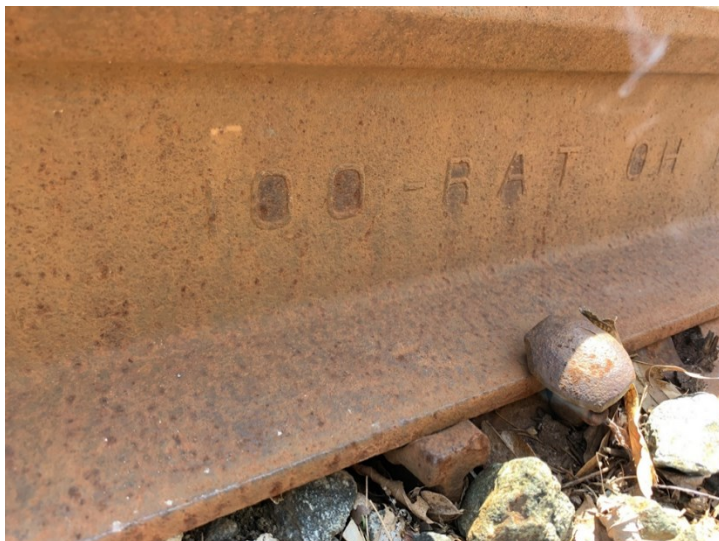
Figure 37: MP 2.37 – Track - Bentham Avenue

Typical 100 lb/yd rail. However, some sections of this line have 115 lb/yd rail.

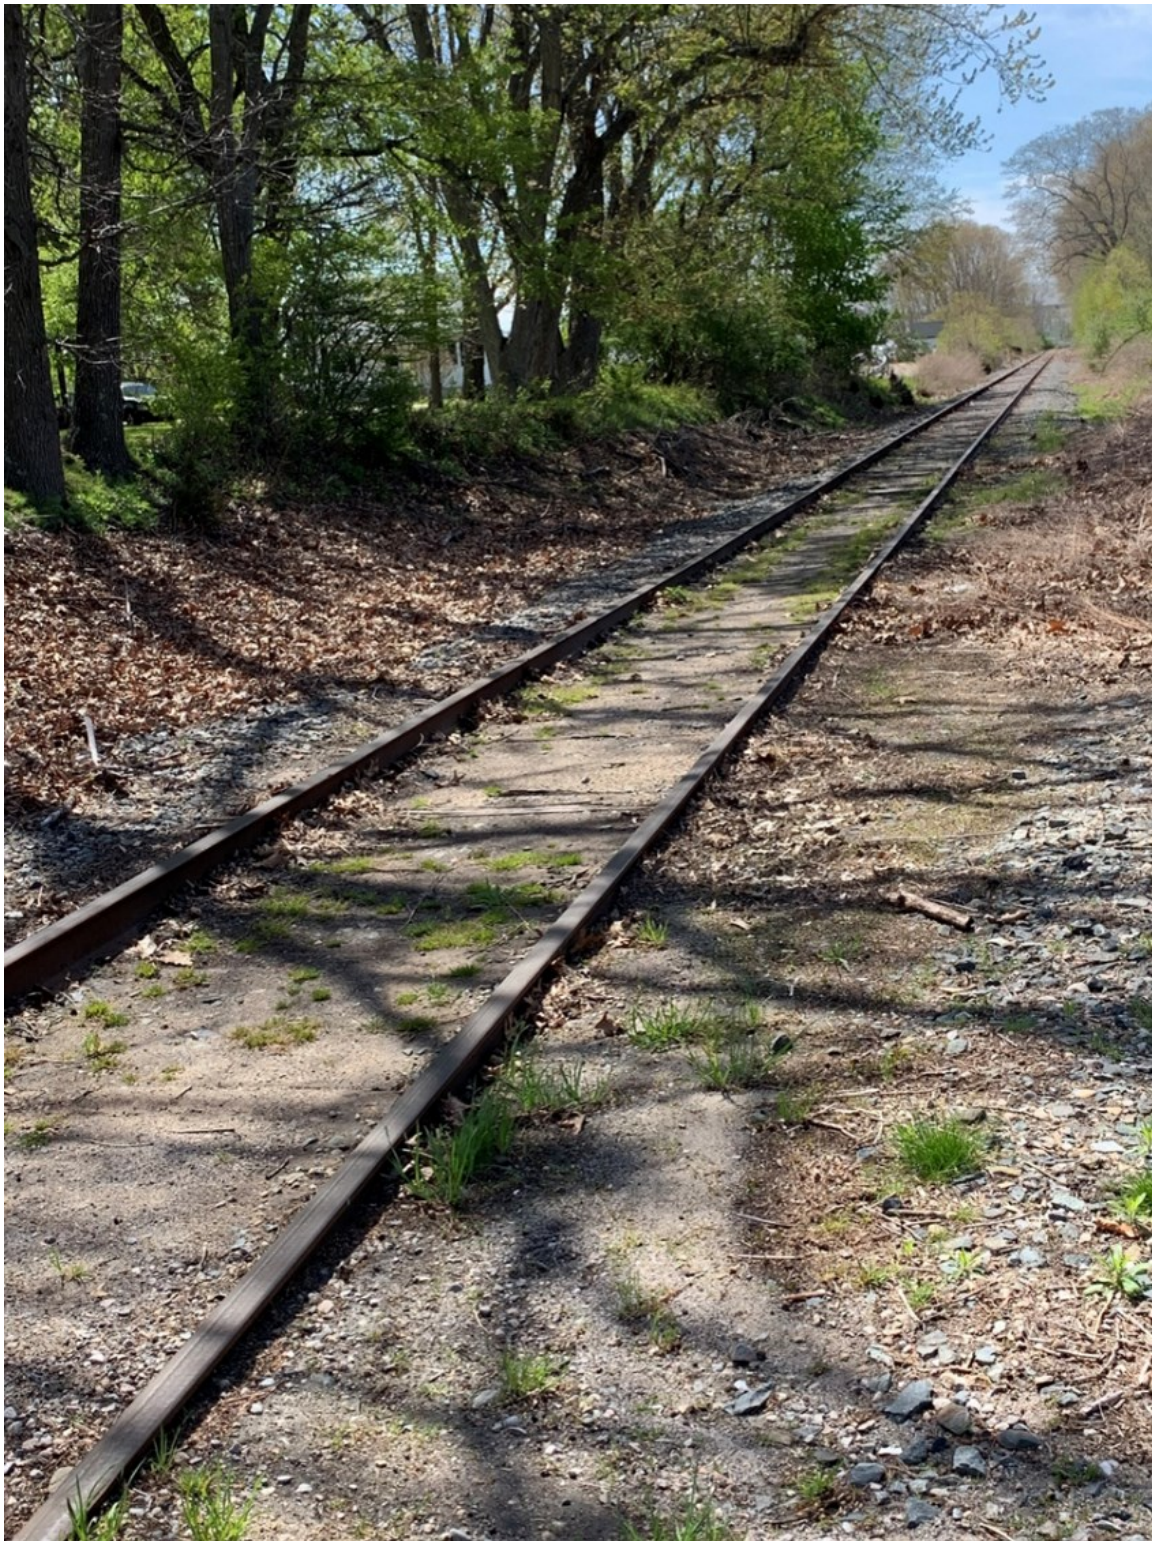
Figure 41: MP 2.37 - Grade Crossing - Bentham Avenue (Looking South)

Some vegetation in the gage and near the crossing. Proper drainage is needed.

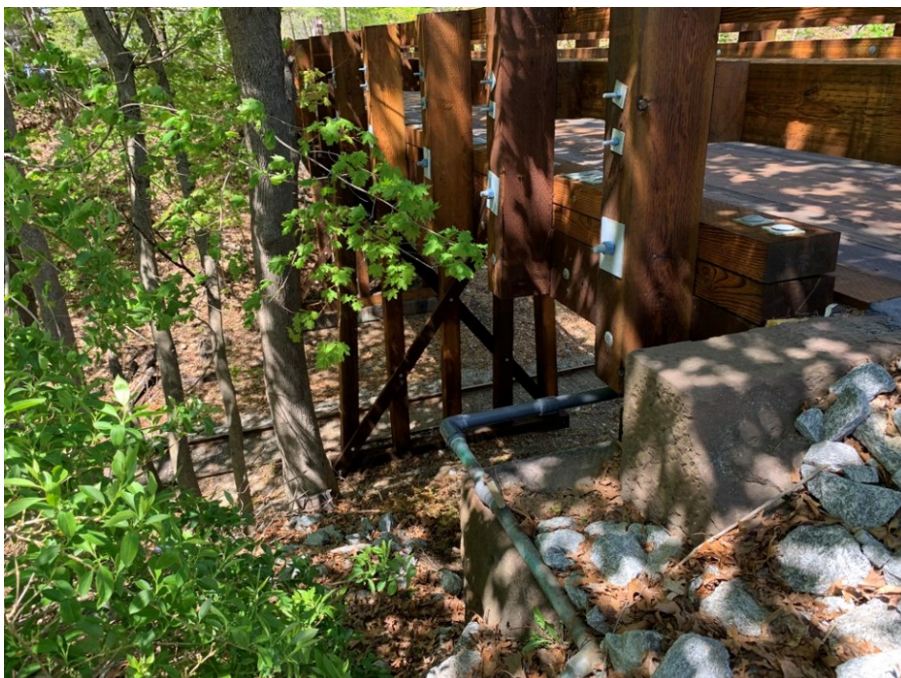
Figure 101: MP 4.45 - OH Bridge -Browns Crossing Road - Timber Trestle (Looking West)

Private timber bridge on Browns Crossing Road. The bridge is in good condition.
